Mirage DSK-8 Service Bulletins

For Mirage serial numbers 10001 - 14731

These service bulletins refer to the original Mirage DSK-8 Sampler.

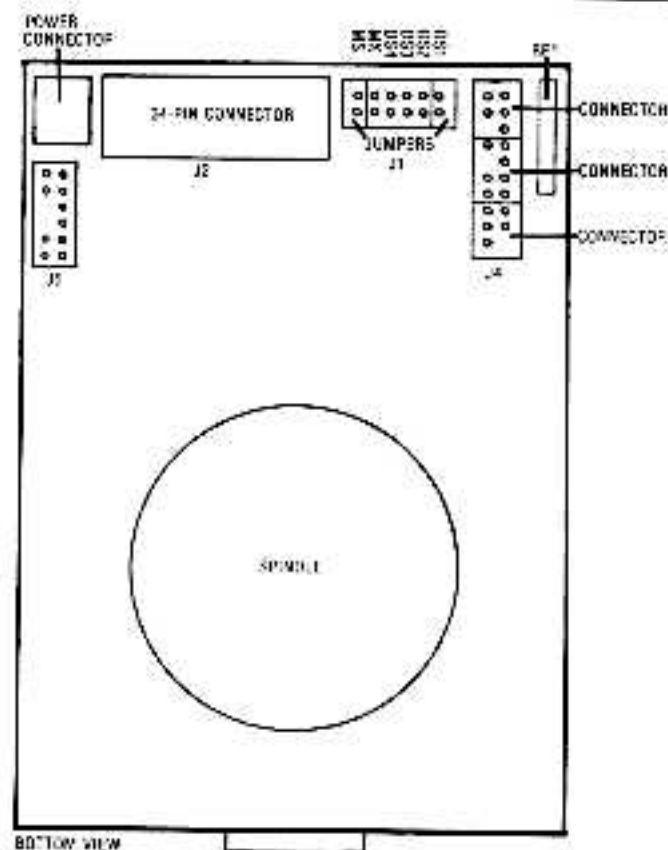
FIGURE 7 — SHUGART SA500 DISK DRIVE

When you have narrowed down the diagnosis to a disk drive problem on Mirages equipped with Shugart Model SA500 drives, perform the following check before returning the drive to Ensoniq.

1. Remove the drive from the Mirage as per the instructions in SECTION D-1 . . . 4 of the Mirage Service Manual.
2. Orient the drive as shown in FIGURE 7.
3. Check the internal connectors of the disk drive at positions J4 and J5 (the J5 connector is one wiring harness while the J4 connector contains 3 separate wiring harnesses).
4. If you find that any of the connectors are not fully seated or completely off the terminals, reinstall the connectors, making sure that they are fully seated.
5. Reinstall the disk drive according to the instructions in SECTION D-5 . . . 8 of the Mirage Service Manual and test the unit.
6. If this procedure corrects the problem, then glue the connectors at J4 and J5 to the circuit board with hot glue.
7. If this procedure does not correct the problem, then the disk drive is bad. Remove the drive and return it to Ensoniq.

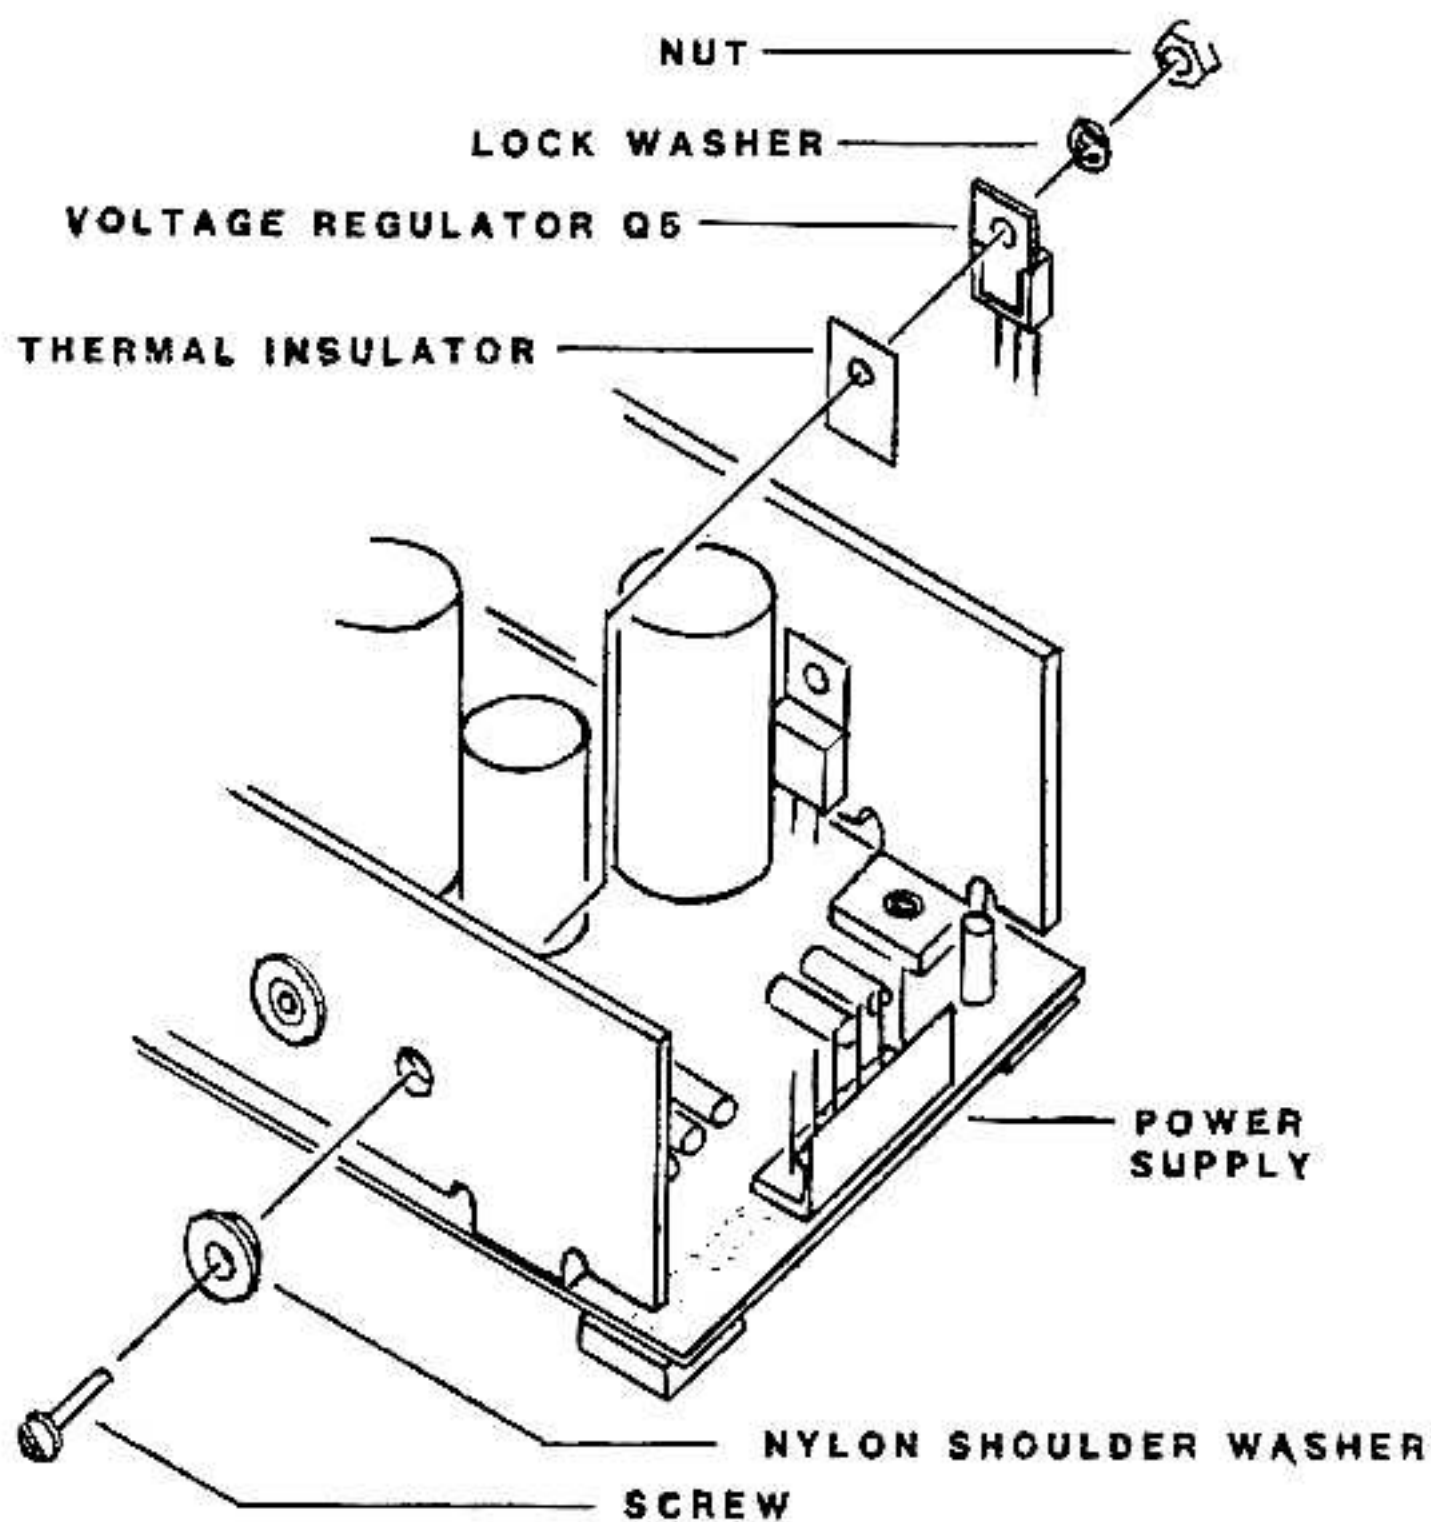
FIGURE B

When you have narrowed down the diagnosis to warrant replacing the main board, always check the power supply for a +12V DC-8V DC voltage value. (Refer to Service Bulletin #1, section 5 to determine the power supply voltage value.) If the power supply does not have this voltage, it must either be replaced with a new power supply or modified (by changing one of the voltage regulators) in the following manner.

1. Follow the directions for removing the power supply in the Mirage Service Manual (section A1...4).
2. Using a drill with a 9/64" drill bit, drill out the rivet on the regulator marked Q5 (see Figure 8). This is the only one with a nylon shoulder washer on those power supplies which have 5 voltage regulators labelled Q1, Q2, Q3, Q4, Q5. The rivet should be drilled out from the side with the nylon shoulder washer.

3. Desolder the leads of voltage regulator Q5 and remove the regulator and the thermal insulator.
4. Insert the new voltage regulator (7908) in Q5 along with the nylon shoulder washer, the thermal insulator, the screw, nut and lockwasher as shown in figure 8.

5. Tighten the screw on regulator Q5.
6. Solder the leads of regulator Q5 on the bottom of the power supply.
7. Inspect for solder joints.
8. Replace the power supply as per the directions in the Mirage Service Manual (A5...6) and allow to burn-in for a few hours.

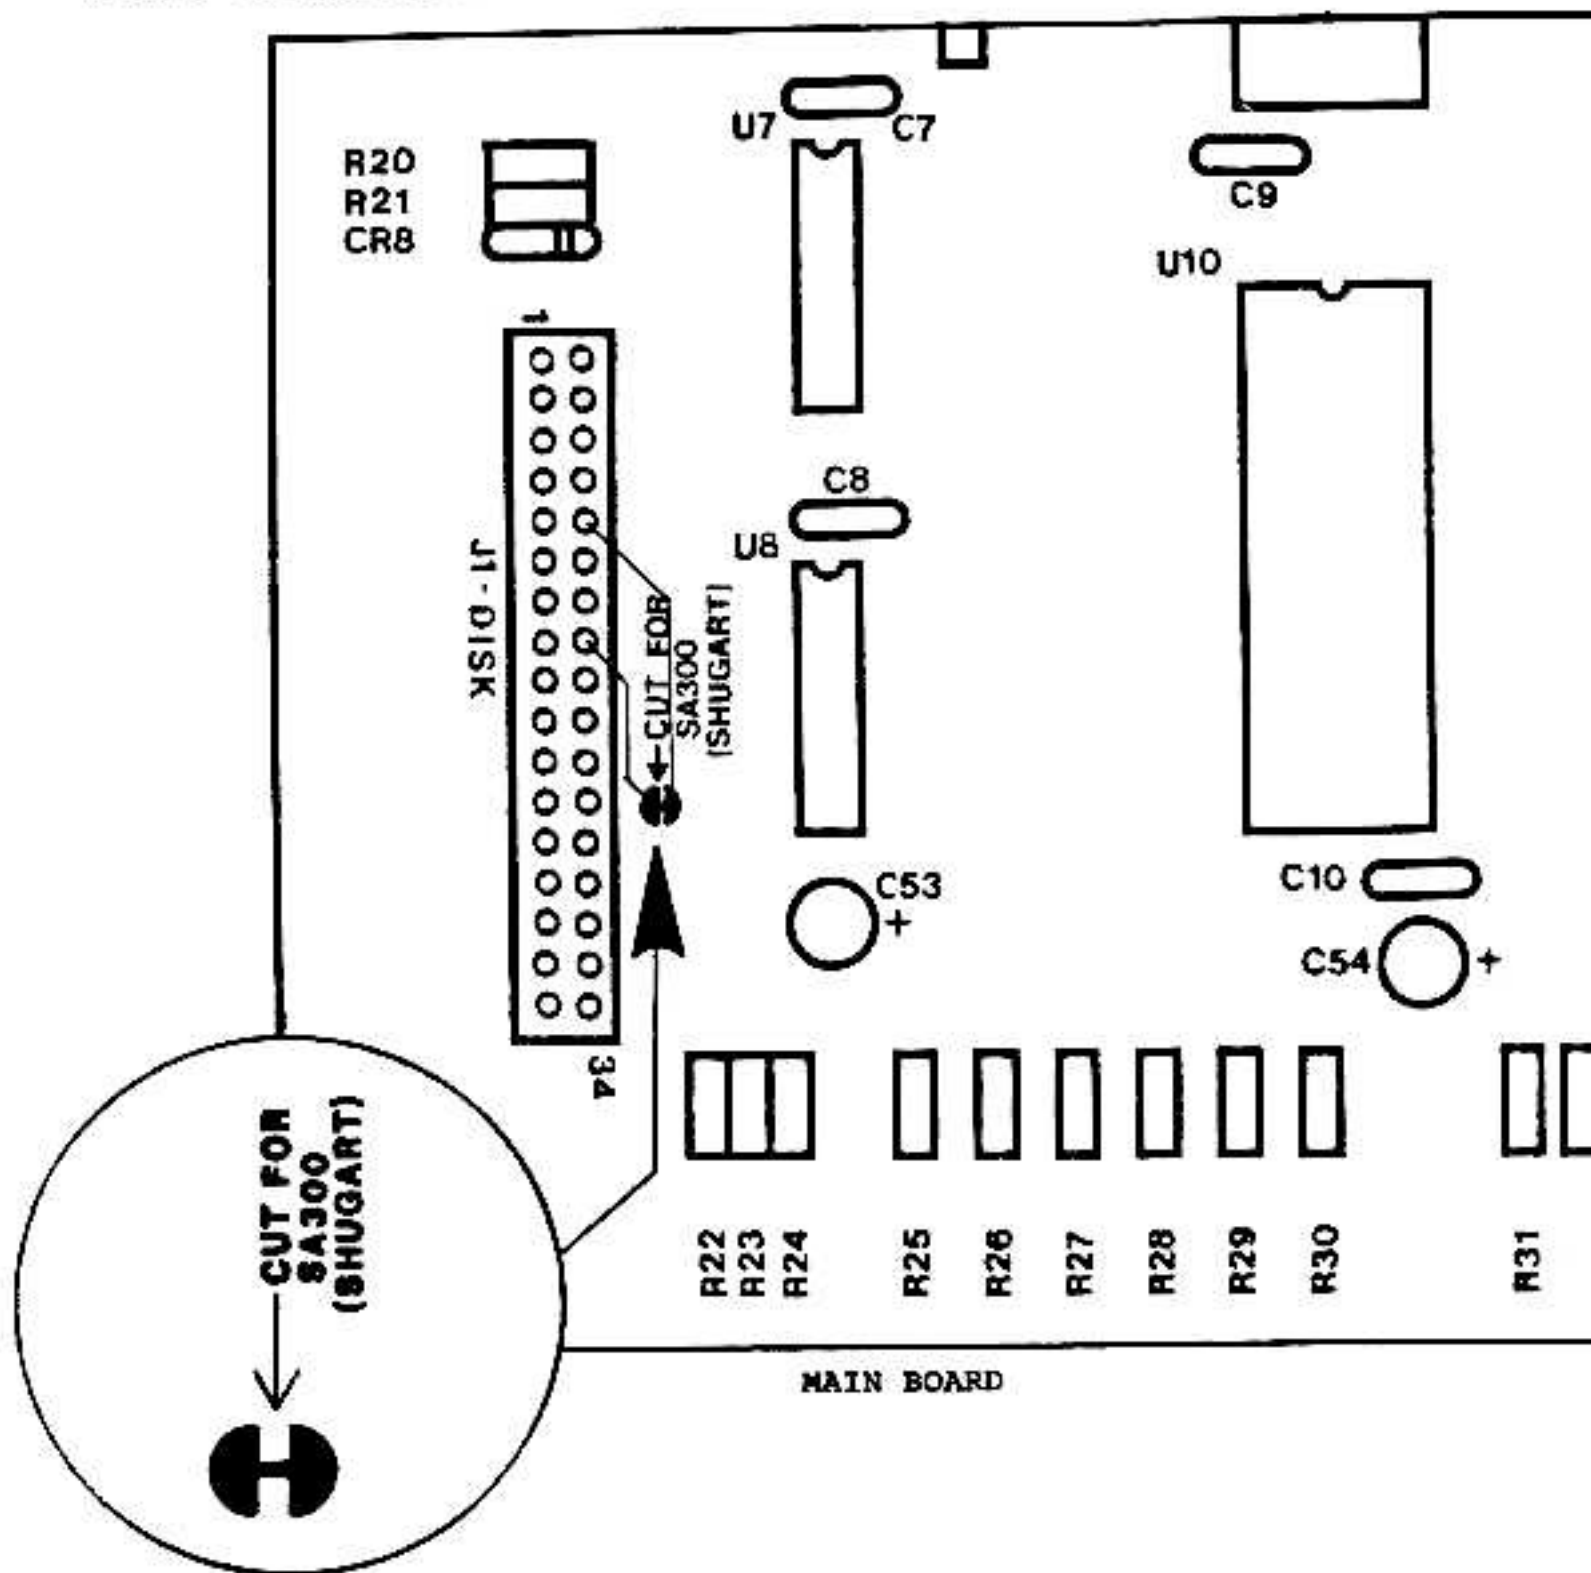
Epson: The disk eject button is located on the lower right of the drive front panel and the 4 pin power connector is located to the left of the ribbon cable at the rear of the drive. On the **main board** a jumper must be shorted at disk drive connector J1 (by shorting this jumper, pins 10 & 16 will be connected).

Shugart: The disk eject button is located in the center of the drive front panel and the 4 pin power connector is located to the right of the ribbon cable at the rear of the drive. On the **main board** a jumper must be out at disk drive connector J1 (by cutting this jumper, pins 10 & 16 will **not** be connected).

The jumper should be cut with a Xacto-Knife (or equivalent) as per instructions in the blow-up of the Disk Drive selector jumper on the other side of this bulletin.

Make the cut on this thin trace that runs between the two pads for the disk drive selector jumper. If the trace is cut at both ends where they connect to each pad it can be peeled off the circuit board. Using a xacto knife (or equivalent type of knife). This will yield a clean jumper cut and will leave the solder pads intact for future reconnection.

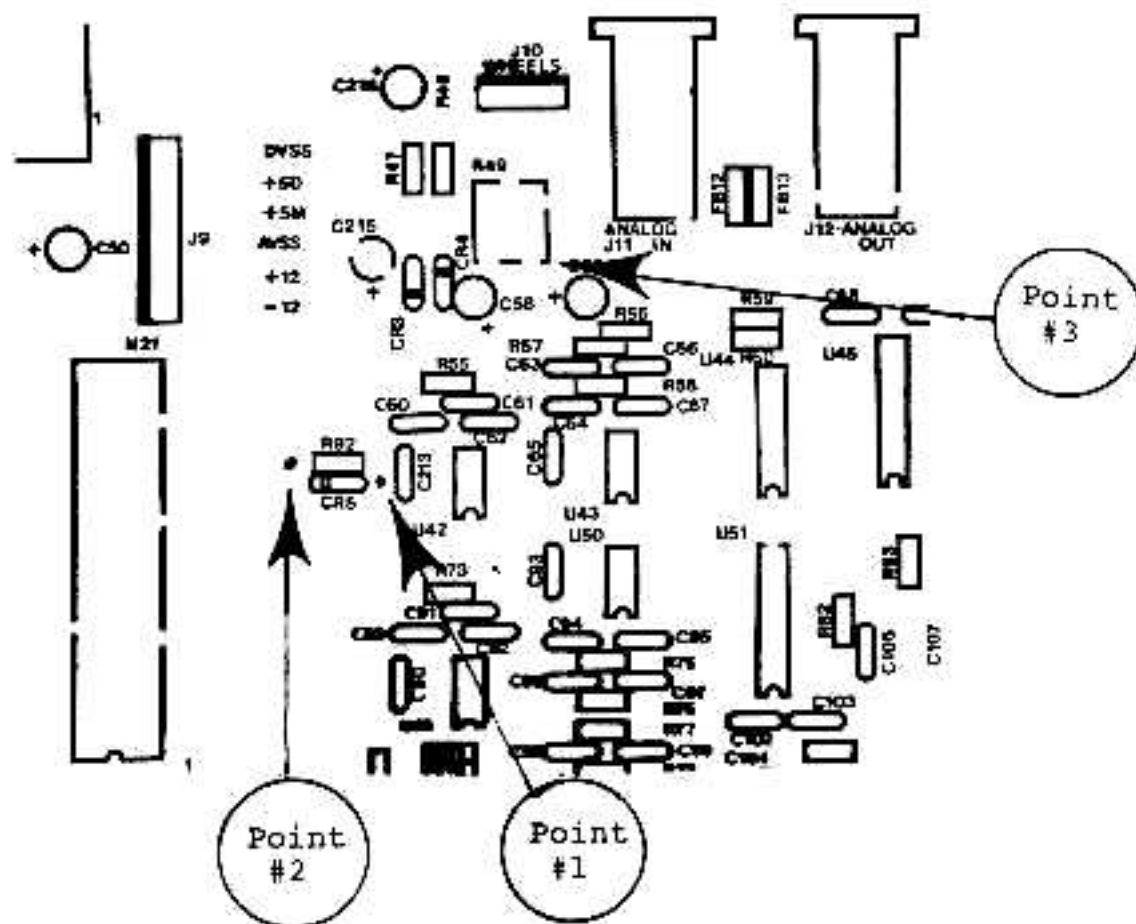
When replacing the Mirage Main Board or the Mirage Power Supply, careful attention must be given to re-adjusting the trimpot located at R49 (Point #3) on the main board. This trimpot sets the volume reference voltage going into the "Q" chip (U21) and if it is not set properly, audio distortion is likely to occur. R49 is located in the upper right hand side of the board, to the left of the Analog-In jack (J11) and directly below the Pitch/Mod Wheel connector, (J10).

The voltage reference point can be accessed by placing the positive probe of your meter on the right lead of CR5, a diode located on the lower right of R92, (point #1). Place the negative probe to Ground, the left lead of R92 (point #2). Adjust the trimpot (point #3) until the meter reads 50 millivolts, or .050 VDC.

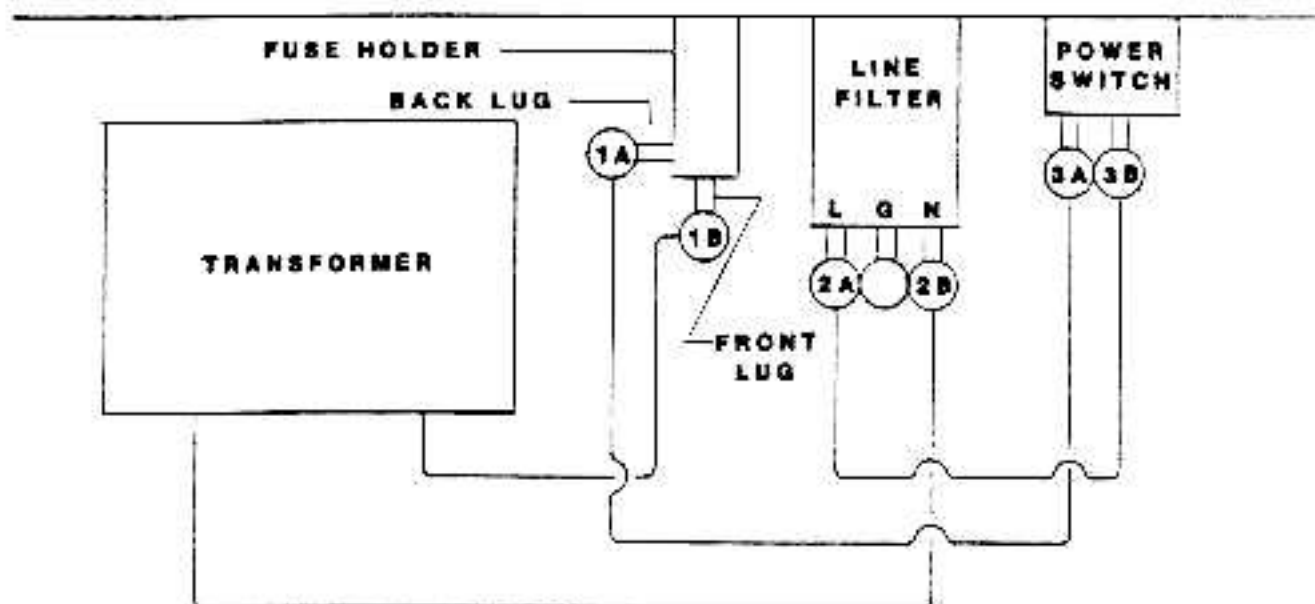
3A

AC LINE VOLTAGE CHECK POINTS
WIRING FOR EARLY MODEL CASE (WHERE TRANSFORMER IS ON THE LEFT).

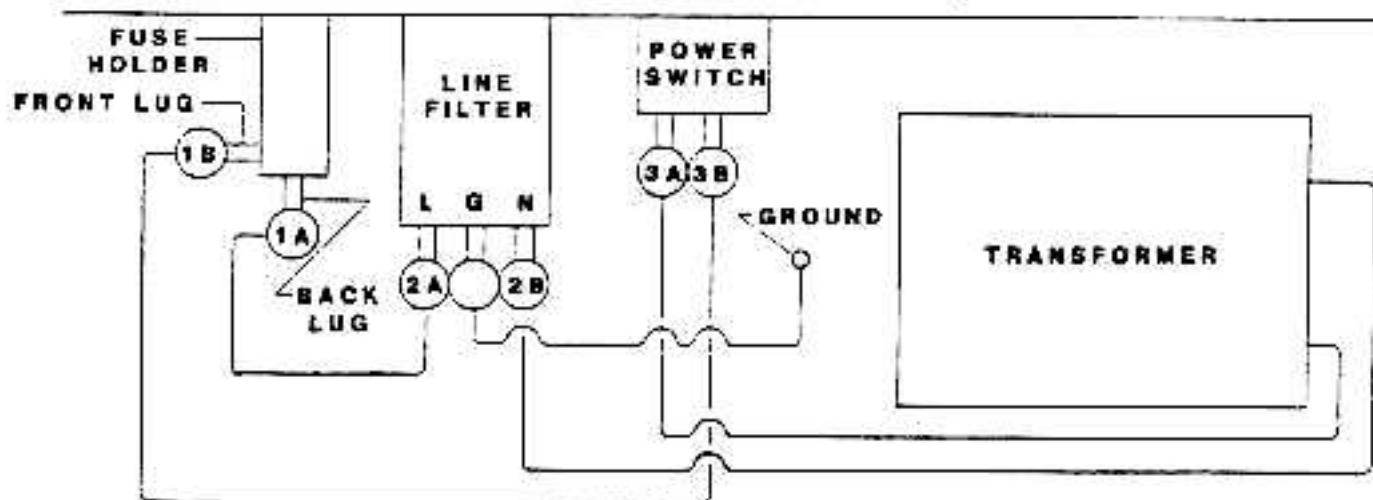
3B

AC LINE VOLTAGE CHECK POINTS
WIRING FOR LATE MODEL CASE (WHERE TRANSFORMER IS ON THE RIGHT).

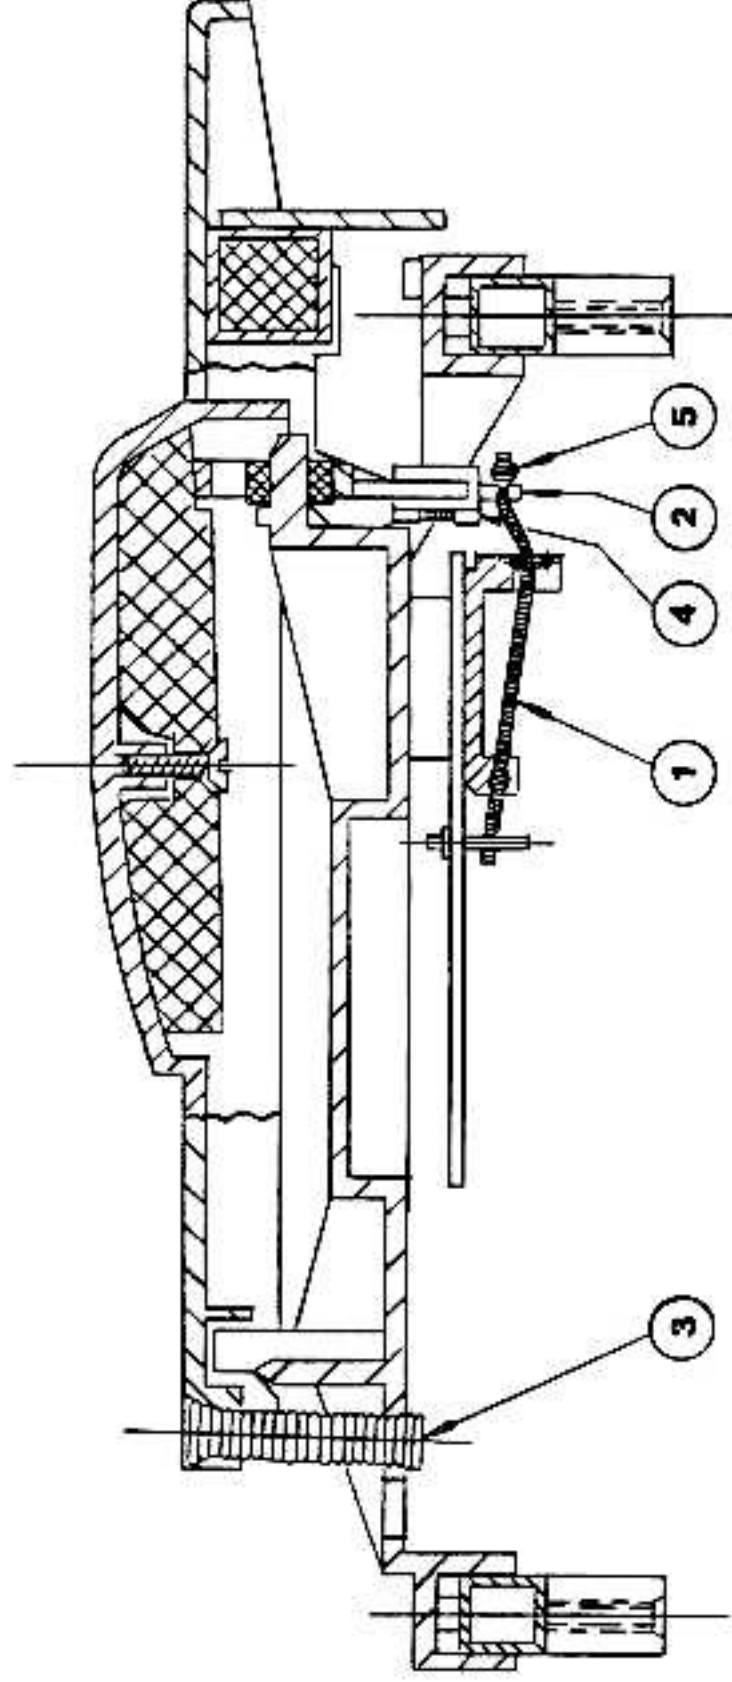
FIGURE 1

Diagnosis: Notes that don't work and/or sound immediately upon boot-up.

Cause: The contact spring may come loose from the front retainer, causing it to rest on the lower contact bar.

Solution: While the spring is detached from the nylon retainer, tin the ball end of the spring with a small amount of solder. Carefully replace this end into the retainer. The solder will prevent the contact spring from working its way through the retainer. Fig 1, item 5.

1. Detach contact spring from nylon retainer. Fig 1, item 1 & 2.
2. Remove rear tension spring from keyboard frame. Fig 1, item 3.
3. Slide key forward, up and out. (When replacing black keys first remove the white keys on either side.)
4. Seat new key on frame and install rear tension spring.
5. Adjust the height of the contact spring retainer so it is level with the rest of the retainers. This will ensure consistent velocity sensitivity across the keyboard. Fig 1, item 4.
6. Replace the contact spring into the retainer.
